The Restoration of a 34 cm Terrestrial Globe by Blaau

Michael Højlund Rasmussen
paperconservator

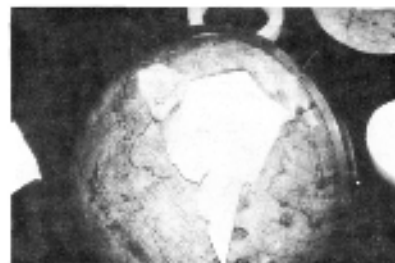
Around the polar regions, about 10 places on the northern hemisphere and in the area representing equatorial Africa (where the globe had received a great punch) plaster and paper were missing and the papier mache shell was more or less visible. Round these areas the gores or parts of them were removed by using steam (see fig.6). The paste dissolved easily as it was obviously dried out several places. In order to stabilize the globe surface the holes were re-plastered. As the plaster would have to resemble the original one of the globe it was made from a solution of rabbit-skin glue and water (1:7) and precipitated chalk mixed to a consistency like that of curdled milk. The plaster was applied hot and was allowed to dry between each application.

Fig.6 Restoration of plaster

Finally the surface was sanded down with sandpaper and sized with wheat starch paste. After the gores had been pasted back on the globe, the holes were repaired with hand laid paper of approximately the same thickness and texture as the original paper. All repairs were retouched with watercolour and the whole globe was re-sized 3 times with a 2% methylcellulose solution.

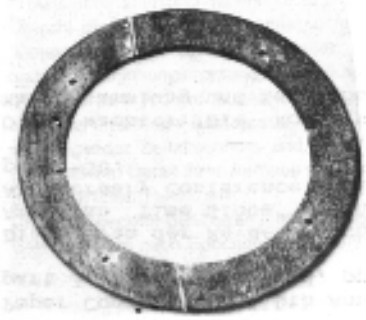
Fig.8 The horizonring restored Fig.9 The globe after treatment

The restoration of the stand was perhaps the most exciting part of the enterprise. As mentioned above the horizon-paper and the horizonring did not fit very well together as the wooden ring had shrunk. In order to save the badly deteriorated paper from being completely disintegrated by tannic acid it was decided to try to peel off the horizon-paper. Another advantage gained by this procedure was the opportunity to restore the wooden ring as well as the paper to its original size. Being aware that such a treatment perhaps was a very hazardous solution to the shrinkage-problem every precaution was taken not to damage the paper. First the paper was cleaned in exactly the same way as the globe. Here it was clearer that the paper had been waxpolished, so again several organic solvents were tested but without any satisfactory results. After having cleaned as much as possible with the methylcellulose/water swabs the paper was ready to be taken off. The horizon-paper was pasted down in 4 pieces the joints following 4 scratches on the wooden ring. The paper was covered with lense-tissue and a thick solution of methylcellulose was pasted through it in order to safeguard the fragile paper on the ring and to retain the moisture to the paper. After this steam was applied by use of a hand steam-cleaner (Rowenta DA-55) and the paper was removed using tweezers and a scalpel. The lense-tissue was a great help during this process; fragments were kept together and it served as a transport. After the removal of the four horizonpapers they were gently washed in hot water and deacidified from the back with a 0,2 % solution of CaOH. In order to remove the protective lense-tissue from the surface the papers were lined on the back with a very thin kozo paper and wheat starch paste. Furthermore, the papers were lined with a rather thick kozo paper which had previously been treated with a 0,2 % solution of CaOH - this should serve as a buffer when pasted onto the oak-ring. Before pasting on the paper the ring was restored to its original size by inserting two pieces of oak-wood in the broken joints. By gently stretching the paper it was made fit the enlarged horizonring.
