# Illuminating Art Using a Daylight System at the Broad Contemporary Art Museum

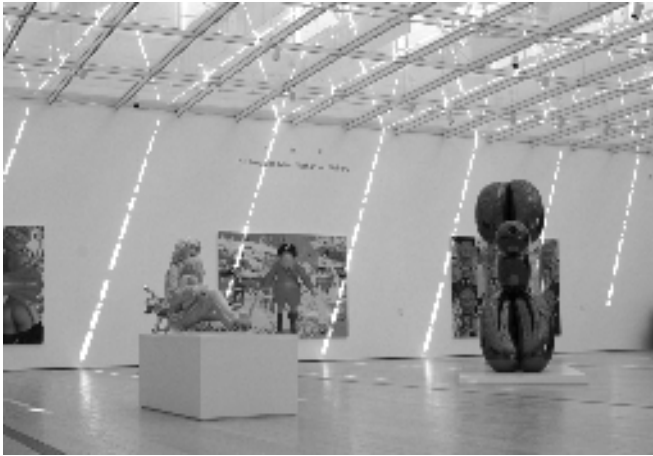
Figure 4 Unfiltered light entering third floor galleries

Attention soon focused on gaps in the design of the roofing system that allowed light to by-pass the roller blinds and enter the galleries. The original design specifications did not propose to provide 100% blackout to the galleries but that some daylight (5%) would pass between adjacent roller blinds. Hem bars that were supposed to be on the bottom of each roller shade were not installed due to a manufacturing problem. The absence of hem bars as well as gaps between the roller shade tube and the inclined roof panels also contributed to unfiltered light entering the third floor galleries and resulted in streaks of light moving across the gallery walls during certain hours of the day (Figure 4).

In order to estimate the amount of light infiltration into the galleries as a result of these gaps additional daylight factor analysis was conducted under total black-out conditions. The contribution due to hem bar gaps and the gaps between the roller shades was predicted to be 2% and 6.6% respec-

tively, yielding a total contribution of 8.6%. This amount was confirmed experimentally by comparing the light transmission of the roller blinds measured in-situ on the roof (15-17%) using an Elsec light meter with the gallery light readings obtained by measuring wall illuminances immediately before and after fully deploying the roller blinds (26%).

Even with the properly manufactured hem bars installed, it was not possible to eliminate the gaps between the roller blinds or the roller shade tube and the inclined roof. For this reason it was decided to replace the roller shades with a fabric possessing a lower visible light transmission to reduce the cumulative light exposure to an appropriate level. A roller blind was selected possessing a visible light transmission of 7% (6% diffuse and 1% direct).

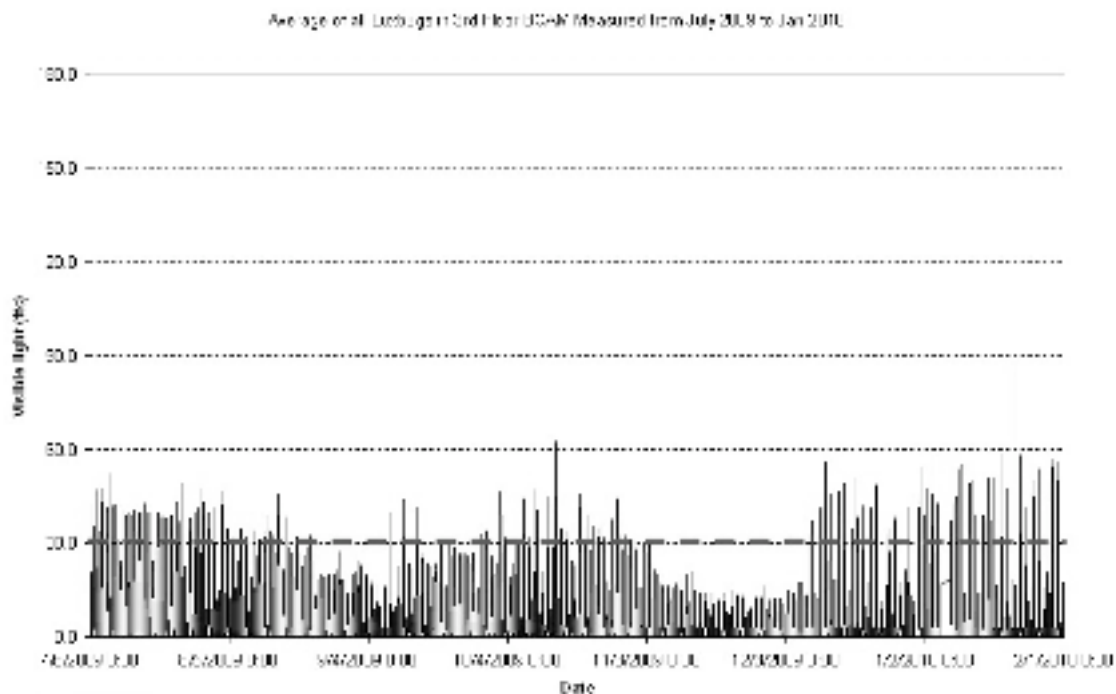
Figure 5 Measured wall illuminance

The results of the light level readings in the galleries from May to December are given in Figure 5 which shows a considerable variability in gallery wall illuminance and a maximum light exposure in excess of the desired 30 ftc.

While the high light levels on certain days can be attributed to on-going changes in the roller blind schedule involving the prolonged retraction of the roller blinds to accommodate roof maintenance and filming in the galleries, the overall trend line is well above 30 ftc during the summer months. This may be due to any number of factors including cumulative tolerance errors associated with measurement equipment, construction, and the daylight/sunlight factor analysis.

It also may be a reflection of how the analysis addresses the difference in transmission of diffuse and direct light through different roller blinds. The high reflectance (~92% reflectance) of the bright white walls in the third floor painted walls is certainly a contributing factor. When a new exhibition was installed in one of the galleries with a change in wall color from bright white to light grey (~56% reflectance), the wall illuminance dropped dramatically.

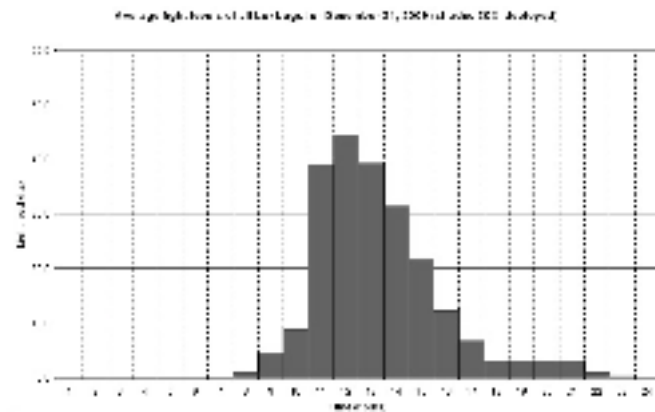
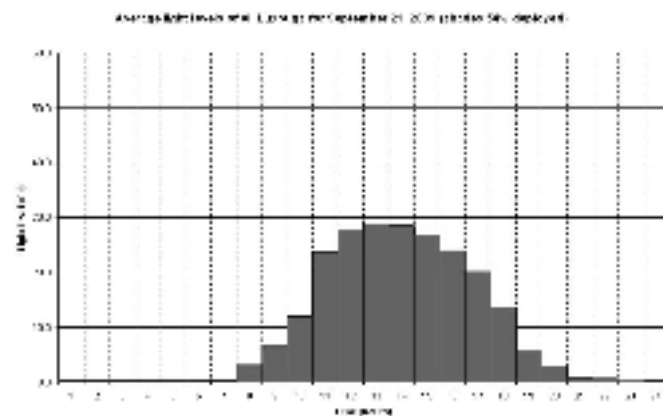
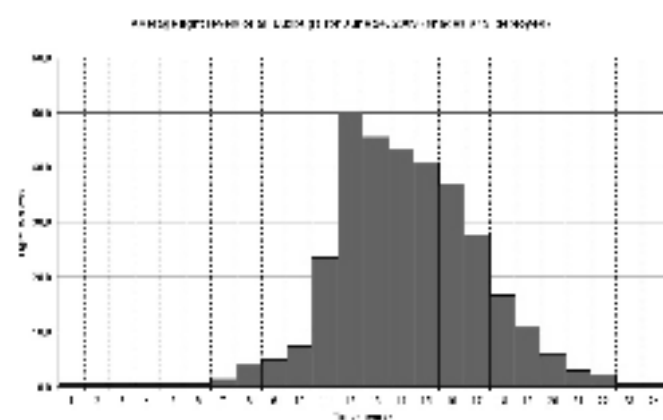
Graphs of the variation in measured data representing the internal wall illuminance at six feet above the floor for a given day in summer, fall, and winter are illustrated in Figures 6, 7, and 8, respectively.

When compared with predicted values illustrated in Figure 3, it is readily apparent that the measured wall illuminance was not always greater than or equal to 19fc as predicted for daylight linking for all museum open hours. The contribution to the gallery light levels provided by the gallery track lighting and the daylight linking system proved difficult to assess.

In general, the system failed to maintain the minimum 19 fc of illumination in the galleries (as defined in the program) during the fall and winter months when the natural light levels fell below 19 fc in the late afternoons and evening hours. This is probably a reflection of the number of gallery lights installed in the gallery which was not sufficient to generate the required wall illumination.
