# Jean Zuber et Compagnie's *Le Paysage à Chasses* at Willow Wall: Removal, Treatment, and Reinstallation of an Early Nineteenth-Century Scenic Wallpaper

Willow Wall, a Georgian-style mansion (ca. 1805–1812) in the village of Old Fields, Hardy County, West Virginia, was added to the National Register of Historical Places in 1973. What is reputed to be a first-strike printing of Jean Zuber et Compagnie's scenic wallpaper, *Le Paysage à Chasses*, hangs in the main entrance hall. Designed by Jean Julien Deltil in 1831, this panorama was hand-printed using approximately 1,250 carved woodblocks and 142 different colors of distemper paint.

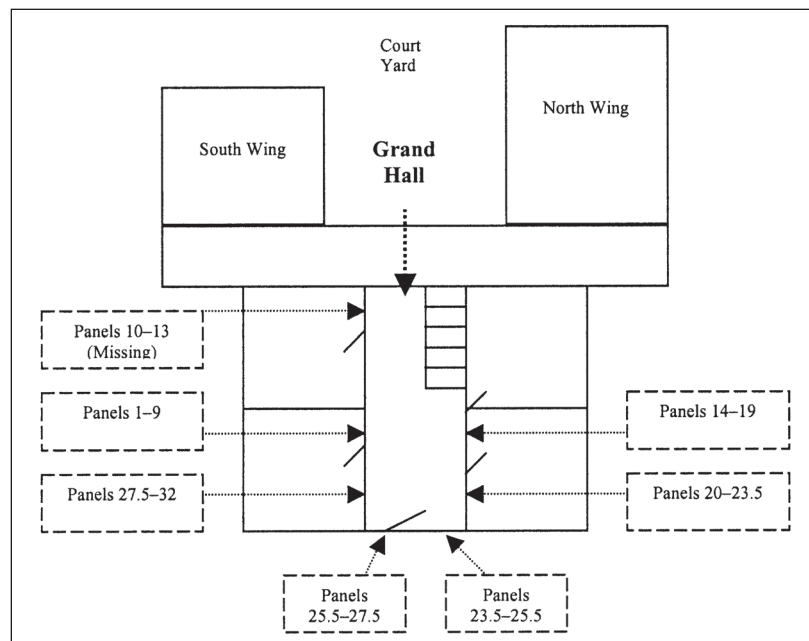
The double-pile floor plan of the main block is laid out symmetrically with a central hall flanked by two rooms on either side (fig. 2). The central hall is approximately twelve feet wide by forty-five feet long; each of the four rooms or parlors is approximately twenty feet square, and the ceilings are fourteen feet tall.

Fig. 2. Diagram of the grand entrance hall at Willow Wall

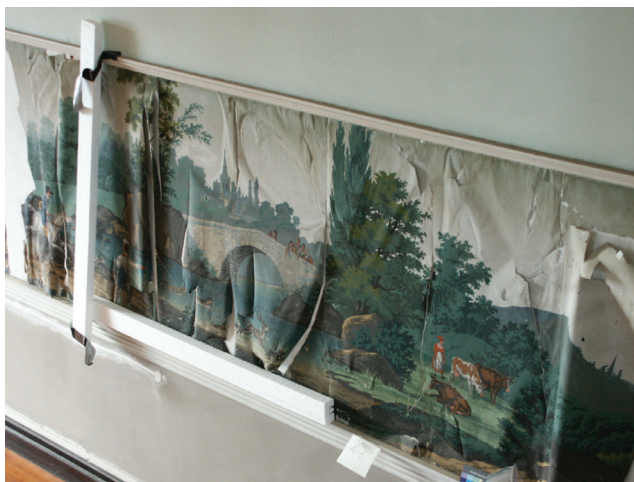
Once attached to a wall, wallpaper becomes the most fragile part of a permanent structure; it is a sort of sacrificial skin that is generally intended to bear the brunt of the wear and tear inflicted by daily life. In a very real sense, most wallpaper is designed to be a temporary feature. When worn, dirty, or no longer fashionable, wallpaper is usually either removed, and often destroyed in the process, or covered over with a fresh coat of paint or a new layer of wallpaper. Because *Le Paysage à Chasses* was a precious luxury item imported from Europe at great expense, it was undoubtedly treated more carefully than less exalted wallpaper would have been. Considering the conditions to which it was exposed, it has survived the passage of time fairly well. The most significant threat to the wallpaper’s preservation was the destructive nature of fluctuating mid-Atlantic temperatures and relative humidity. Paper fibers, the animal glue binder in the distemper paints, and the starch-based adhesive used to adhere the panels to the walls all experienced alternating cycles of expansion and contraction that were ultimately responsible for the majority of the damage incurred. Large areas of starch paste failed, causing panels to delaminate from the plaster walls in irregular patterns. Tears and losses occurred as the wallpaper was increasingly required to support its own weight along areas of partial delamination (fig. 3).

Fig. 3. The torn, partially delaminated wallpaper supported by Styrofoam braces.

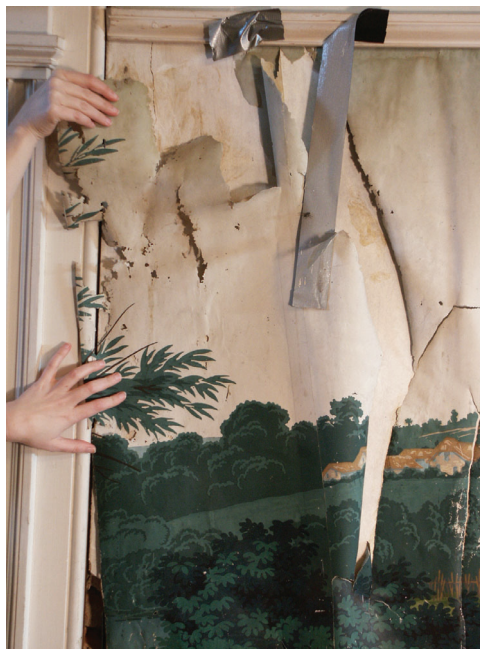
Amateur repair efforts over the years had readhered detached areas using handy but nonarchival materials such as rubber cement, white glue, and duct tape. The rubber cement had turned a distinctive orangey-brown color as it aged, and this contributed to an unattractive murky appear-

ance that was visible in places on the recto (figs. 4–5). The full extent to which rubber cement had been used was not apparent prior to removal. In addition, the animal glue binder in some of the distemper paints had failed as well, especially on panels that were water-damaged and adhered to an exterior wall. This resulted in several panels with extremely fragile, friable, and flaking paint surfaces that were disfigured by the loss of image material (fig. 6).

Fig. 4. Tears, insect predation, embedded grime, discoloration from contact with rubber cement, and duct tape

Because the rubber cement on the versos would have continued to discolor, cross-link, and deteriorate if left in place, and because it would have formed a barrier to uniform humidification and prevented firm adhesion between the primary support and the lining paper, the decision was made to remove it. Because of the size of the panels, the probability of driving the discoloration from the rubber cement through to the front of the wallpaper, and the vast quantity of acetone that would have been required for solvent treatment, rubber cement residue was removed mechanically with great care using scalpel blades and various grades of abrasives. Crepe erasers were used to remove the small amount of rubber cement that was still tacky.

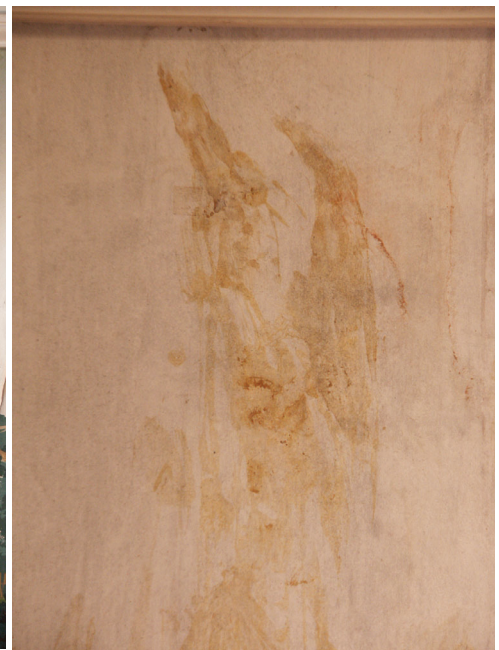
Fig. 5. Rubber cement residue left on the plaster after the removal of the wallpaper panel visible in figure 4

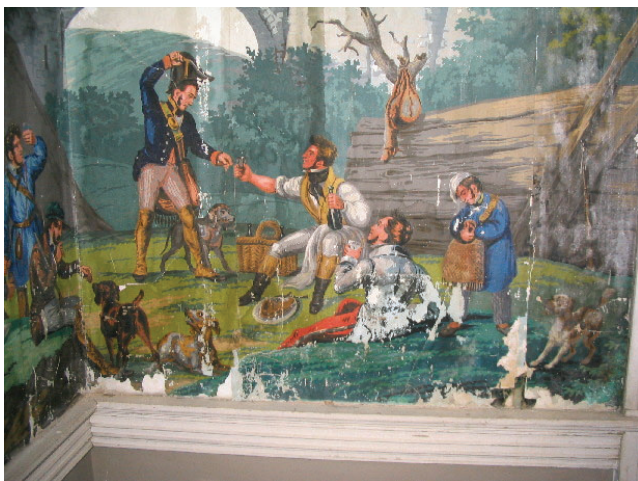
Fig. 6. This water-damaged panel with flaking paint surface was adhered to an exterior wall to the left of the front door

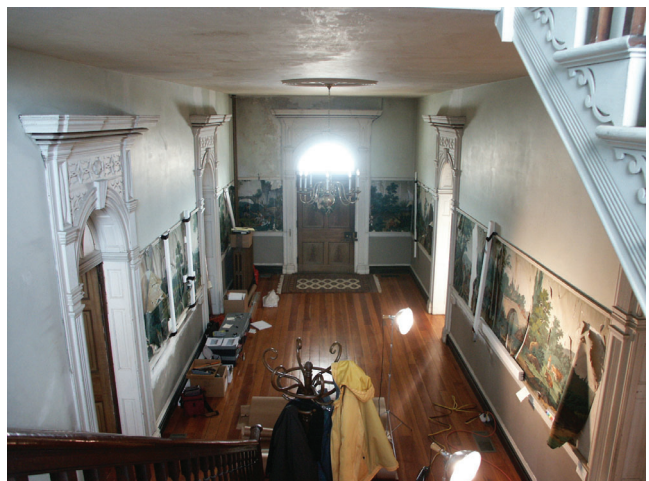
As can be seen in figure 7, the wallpaper was no longer eight feet high in 2004. A great deal of water damage occurred when the house stood vacant for several years in the 1940s. The upper four feet of sky was removed as a result, and a strip of wooden molding was added. Panels 10–13, which occupied a wall directly beneath the landing from which figure 7 was photographed, were also removed at some point and are now lost.

Fig. 7. The grand entrance hall looking toward the front door

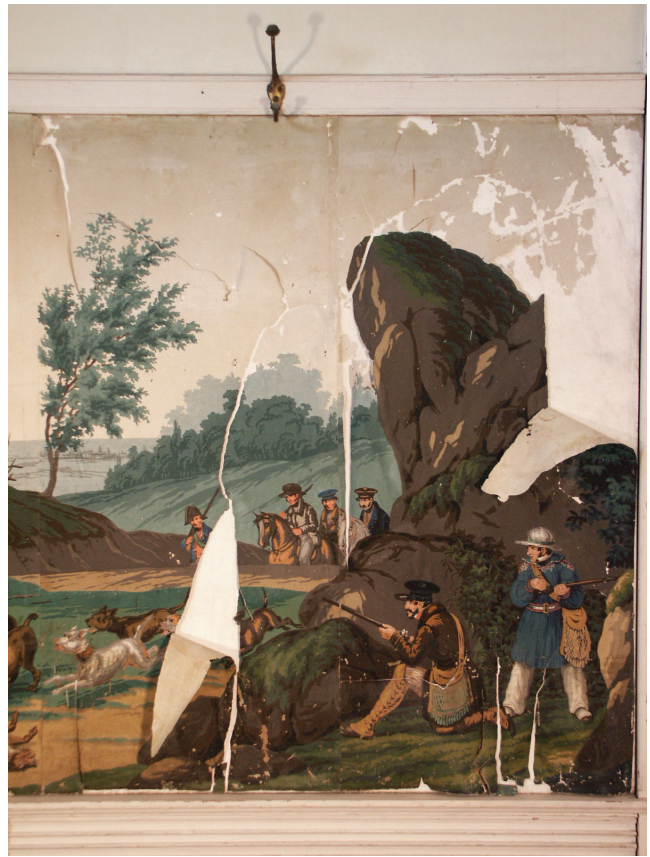
(Museum of Fine Arts 2007).<sup>3</sup> Insects feasted on cellulose and starch paste, although notably not on the arsenic-containing greens (fig. 8). Mold grew on the water-damaged panels adhered to the exterior wall, and generation after generation of flies left their marks behind. In addition, sections of the wallpaper were removed to accommodate electrical outlets, light switches, and a radiator.

Fig. 8. Embedded surface grime and insect predation

With the exception of those areas that were too fragile to bear the abrasion, rectos were surface-cleaned using Mars Staedtler white vinyl eraser crumbs. Although the original plan was to remove all of the flyspecks mechanically, this resulted in minute but pronounced media loss that proved to be too disruptive to the paint surface. The majority of the insect accretions could not be removed safely.

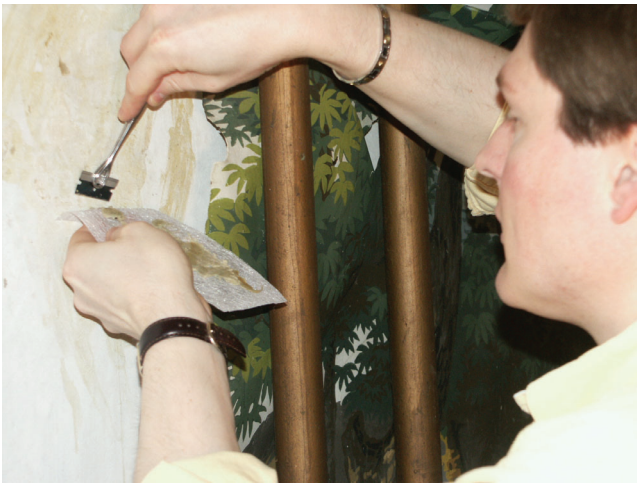
cement residues remained on the versos of several panels until they could be removed completely in the conservation lab (fig. 9).

Fig. 9. Bryan Draper uses an improvised razor tool

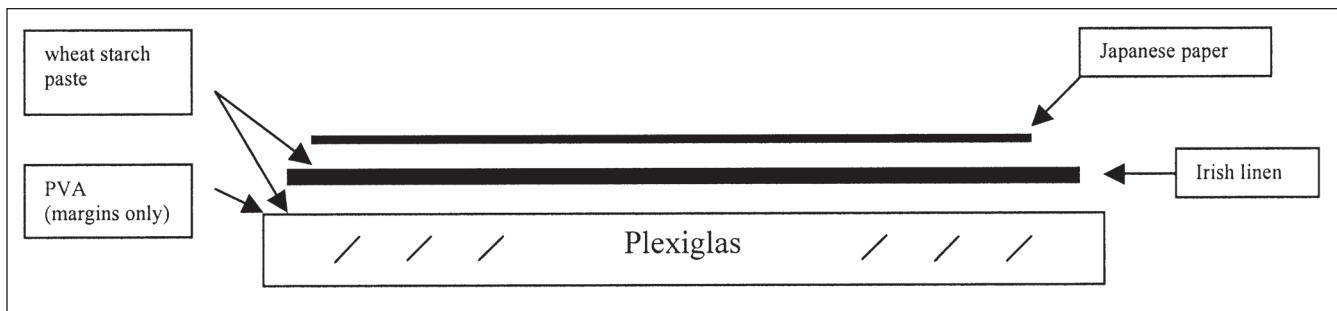
The individual wallpaper panels that would hang together on a section of wall were lined onto a larger temporary lining panel made on a one-fourth-inch thick Plexiglas board. Unbleached Irish linen and Japanese paper, RK 29 from Paper Nao, were the new structural support materials. Each Plexiglas board was cleaned to remove grime and to abrade the surface in preparation for lining. Unbleached Irish linen was soaked in water alkalinized with ammonium hydroxide to remove residual sizing and impurities, and then the fabric was rinsed. A very dilute wheat-starch paste was applied to the prepared Plexiglas. The wet linen was stretched onto the Plexiglas, and then the Japanese paper was lined onto the linen using wheat-starch paste. The margins of the linen, approximately one inch all around, were adhered to the Plexiglas using Jade 403 PVA emulsion adhesive, and then the lining panel was allowed to dry completely. A total of four large (4 ft. x 8 ft.) and three small (4 ft. x 5 ft.) lining panels were prepared (fig. 10).

Fig. 10. Diagram of a temporary lining panel

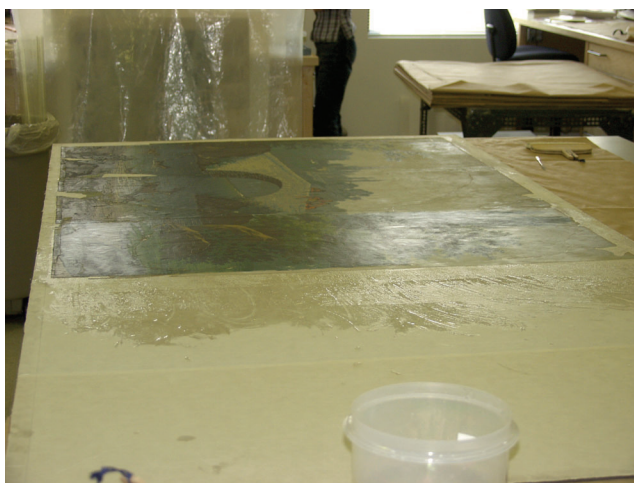
Fig. 13. Lining in process

The dry lining panel was coated with wheat starch paste. A layer of 4% methyl cellulose was added to provide an increased degree of slip to assist in the manipulation of fragments. The relaxed wallpaper panel was carried to the lining paper on a sheet of Mylar (fig. 11). Each panel had to be positioned carefully, because it was very difficult to realign once in place. Adjustments had to be made without touching the fragile distemper surface (fig. 12). Adhesion was ensured and excess moisture, adhesive, and air bubbles were removed by brushing the surface through Hollytex. The entire lining process was then repeated with the next wallpaper panel (fig. 13).

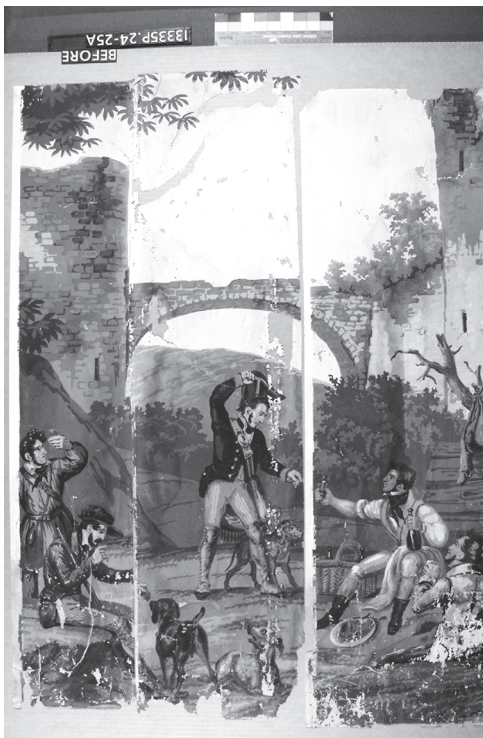
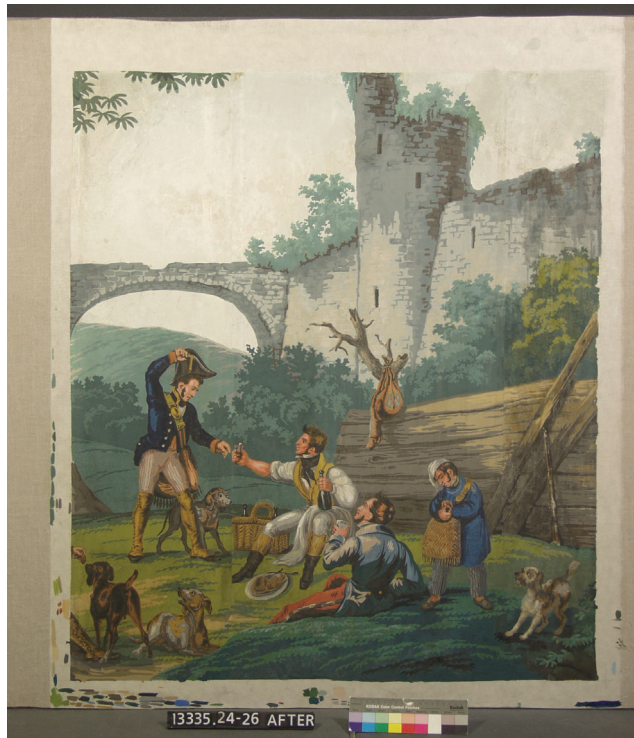
Fig. 14. Before inpainting

Fig. 15. After inpainting

Prior to inpainting, areas that still had friable paint surfaces were consolidated using 0.5% methyl cellulose dissolved in ethanol. Winsor and Newton watercolors and gouache were used to tone the Japanese lining paper in places where the original material had been lost. No additional Western paper fills were added. Abrasions in the original surface were also toned to restore visual continuity (figs. 14–15).

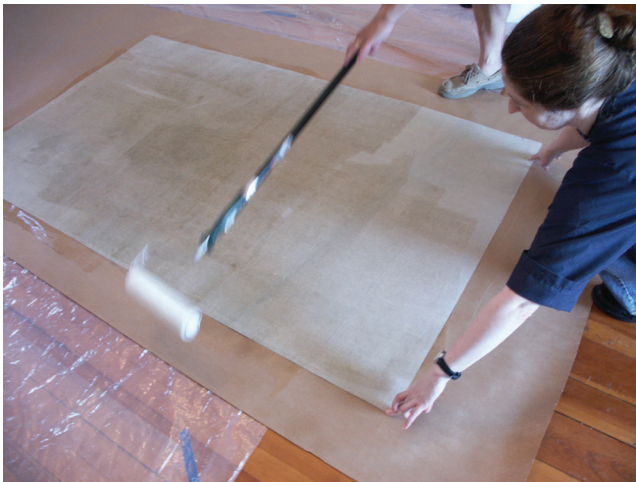
Fig. 16. Applying methyl cellulose with a paint roller

Methyl cellulose was selected as the reversible adhesive of choice because it is less appealing to insects than wheat-starch paste—which had, in any case, already demonstrated its willingness to fail. In order to ensure uniform adhesion, the walls were sized with two coats of 1% methyl cellulose and left to dry overnight. The next morning, wallpaper panels were adhered to the walls using 4% methyl cellulose. Adhesive was applied to the Irish linen versos using a paint roller (fig. 16). The wallpaper panels were transported to the walls taking care to disturb the damp paint surface as little as possible (fig. 17).

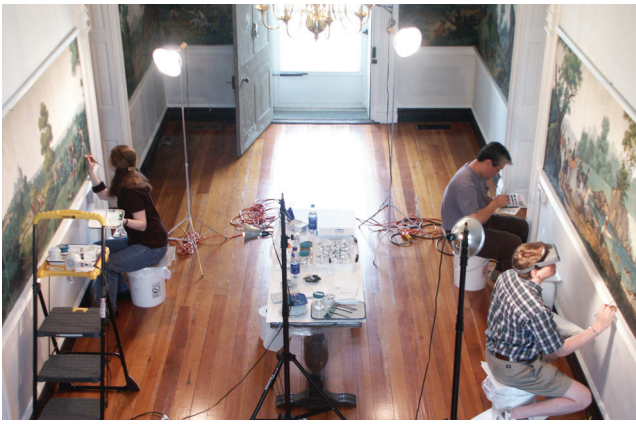
Fig. 18. Final inpainting

were removed by brushing the wallpaper surface through Hollytex. When dry, final in-painting could be completed (figs. 18–21).

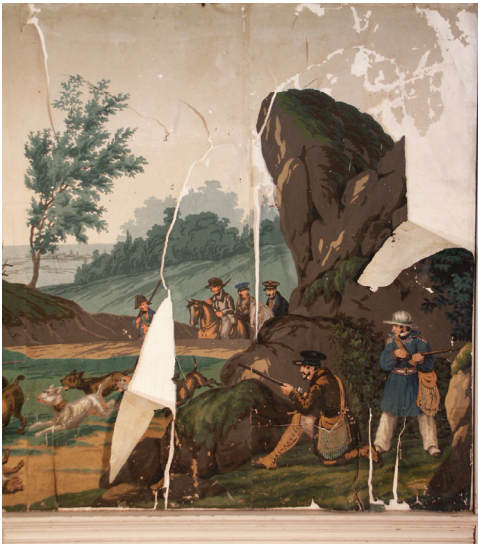
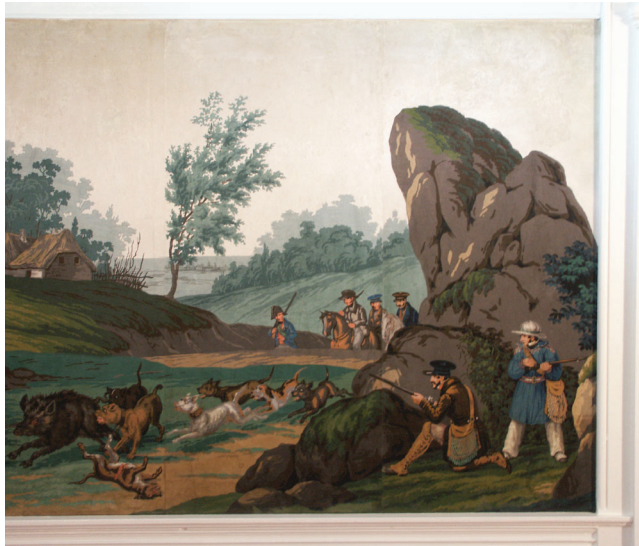
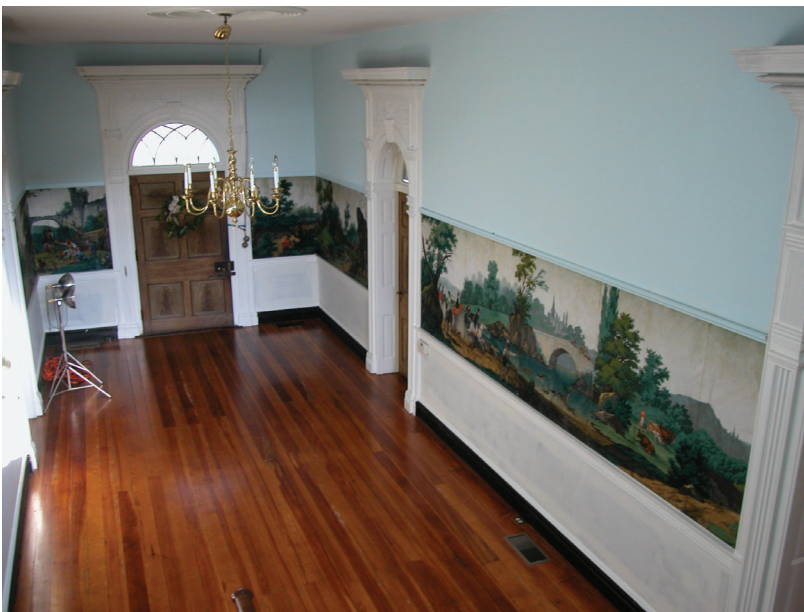
Fig. 19. Before treatment

Fig. 20. After reinstatement

Fig. 21. Overview, after treatment
