Paper, Pins, and Preservation: The Evolution of Wallpaper Conservation in a “Ruin” Environment

THE LOWER EAST SIDE TENEMENT MUSEUM

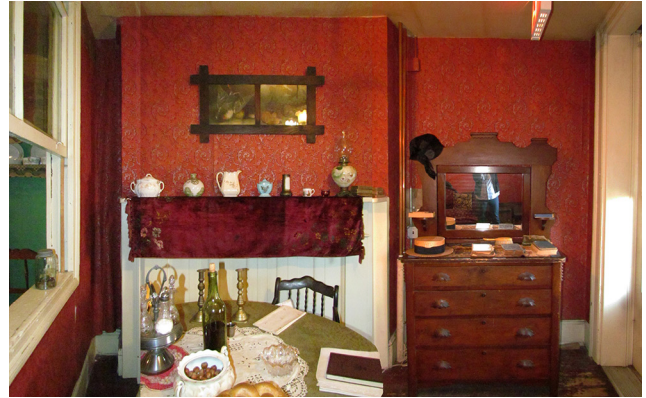
Fig. 1. Parlor of the “restored” Rogarshevsky apartment.

The museum classifies their apartments into two different categories, “restored” and “preserved.” Restored apartments are those which have been restored or reconstructed to a specific time period in the building’s history and are used as interpretive spaces. These apartments tell the story of actual residents of 97 Orchard Street using information gathered through historic research and family histories. Restoration treatments included new plasterwork and sheet rock, skim coats of plaster over historic finishes, painted finishes, and new wallpaper (fig. 1).

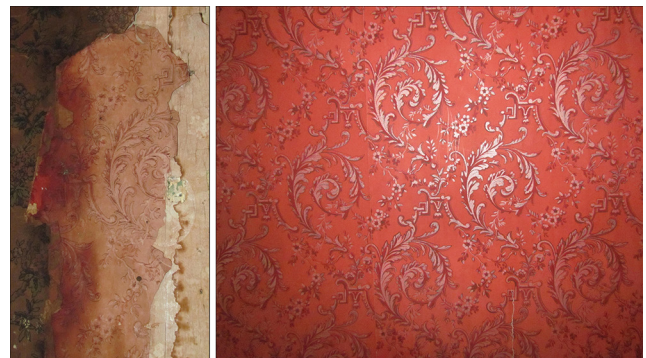
Fig. 2. Historic wallpaper on the left was recreated for the Rogarshevsky parlor (right).

Ms. Snyder and the museum worked with wallpaper company Scalamandre, who provided their services pro-bono, to recreate some of the papers found during the analysis. The floral paper used in the Gumpertz parlor is a reproduction of the earliest wallpaper discovered in the museum. The red wallpaper used in the Rogarshevsky parlor is the 14th layer found in Apartment 11 (fig. 2). Based upon the wallpaper’s location within the stratigraphy of the layers, and the color and style of the wallpaper pattern, museum curators determined that this paper most likely dated to circa 1910, when the Rogarshevsky family would have been living in the building.

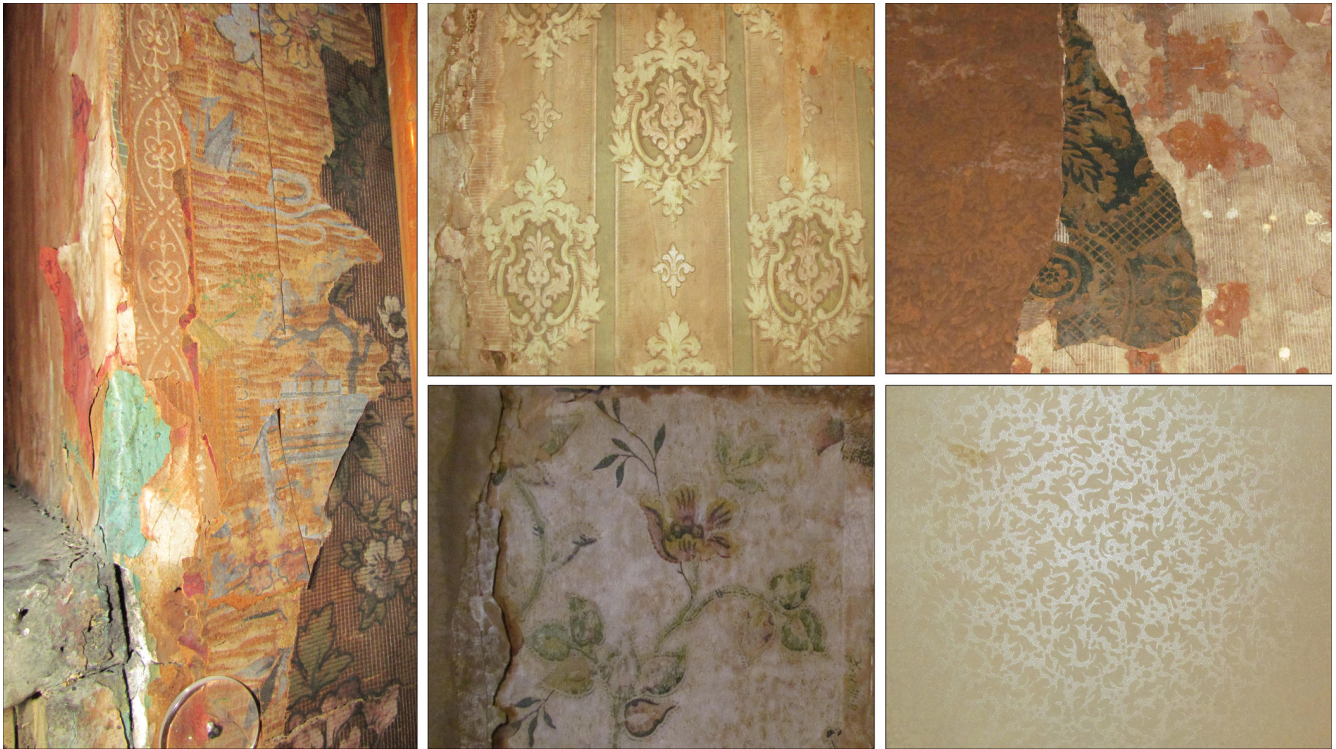
Wallpaper was a popular interior finish for the working poor as can be seen in the majority of the apartments at the Tenement Museum where there is a wide array of patterns including Asian-inspired designs, abstracts, florals, brocades, and stripes (fig. 3). Borders, running around the perimeter of rooms, are found in both floral and geometric patterns.

Fig. 3. Examples of wallpapers found within the LESTM apartments.

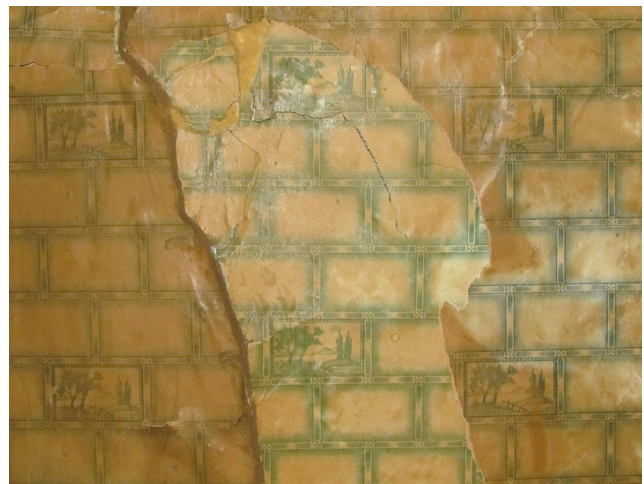
The Tenement Museum also has examples of sanitary papers. The late 19th century saw a great rise in sanitary concerns and wallpapers were frowned upon as decoration because they could not be cleaned. Wallpapers accumulated dirt, soot, and grease, and were thought by some to harbor insects and disease. Sanitary papers were seen as the answer to this problem, having a coating of varnish which allowed them to be washable. An 1887 article in the *Journal of Decorative Arts* entitled “The Homes of the Lower Classes; How to Make Them Sweet, Clean, and Beautiful,” stressed the use of this “economical and hard wearing” paper for “poorer households.” The walls of the kitchen in Apartment 11 were finished with at least two layers of sanitary paper. The design on this paper is one that was popular for many sanitary papers, which is in imitation of another material known for its sanitary properties—ceramic tiles (fig. 4).

Fig. 4. Washable “sanitary” paper found in the kitchen of Apartment 11.

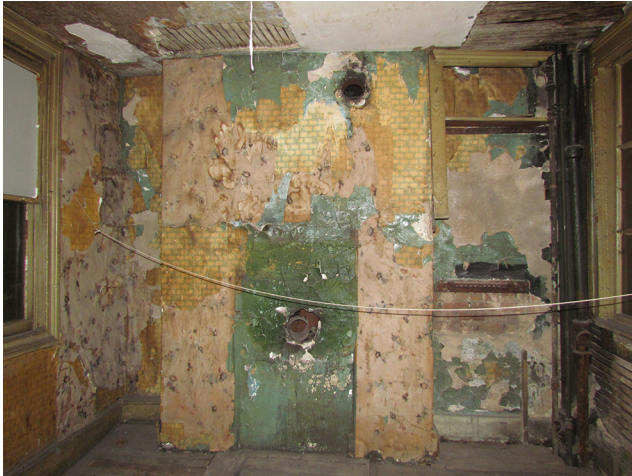
Fig. 5. “Preserved” kitchen of Apartment 11.

These historic wallpapers are all found at the Tenement Museum, in what they call a “preserved” apartment. The preserved apartments are those spaces which have been stabilized in their as-found condition and presented as “ruins” (fig. 5). These apartments endured over fifty years of water infiltration, uncontrolled fluctuations in temperature and humidity, and general neglect. Many of the papers in these apartments are in poor condition. They are stained, torn, and sagging. Additionally, these apartments also exhibit substrate conditions which greatly affect the historic paper, including exposed lath, peeling paint, and cracked, bulging, and detached plaster.

Analysis of the historic wallpapers found them to be pigmented Kraft-based papers with starch and glue paste adhesives. So, in addition to the damages caused by fluctuations in temperature and relative humidity, exposure to ultraviolet light, and failures of the substrate, these papers are also affected by the oxidation of the acidic wood pulp paper which caused the paper to darken, become brittle, and lose strength over time.

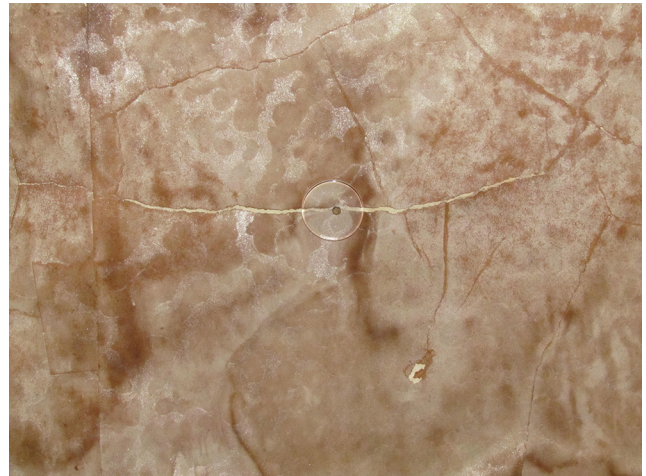
The pinning treatment, however, also had its drawbacks. While an effort was made to place the pins at an edge of the paper in order to not perforate it, this was only successful if all of the paper edges are aligned. Due to the manner in which the wallpapers have torn, the edge of the top paper is often stepped back from the layers below.

Fig. 6. A pin placed along a tear to prevent puncturing the wallpaper.

museum where multiple pin holes have been punctured into the paper, but no pin remains. These pins kept falling out due to the numerous layers of wallpaper which have nothing behind them into which the brad can secure. In other locations, the pins remain in place, but have become loose causing the rectangular pins, which were initially installed vertically, to rotate on the brad to a horizontal position. Additionally, much of the plaster in the museum is precarious and even gentle hammering can cause it to become detached.

In an effort to avoid the creation of additional stains caused by the adhesives on some wallpapers, buttons or pins were also used to re-attach the loose paper to the plaster walls. The pins are clear acrylic, 1/16-inch thick, in a variety of shapes and sizes with edges sanded smooth. They were installed with small stainless steel brads inserted through a pre-drilled hole in the button and gently hammered into the plaster (fig. 6). Rectangular pins were generally used for securing long tears; large disks for joining multiple tears; and small disks for small adhesion areas.

If the pins were carefully placed at the edge or along a tear, it was possible to re-adhere the wallpaper without puncturing it. Once installed, the clear pins do not block the pattern of the wallpaper and are often difficult to discern when viewed from a short distance from the wall.

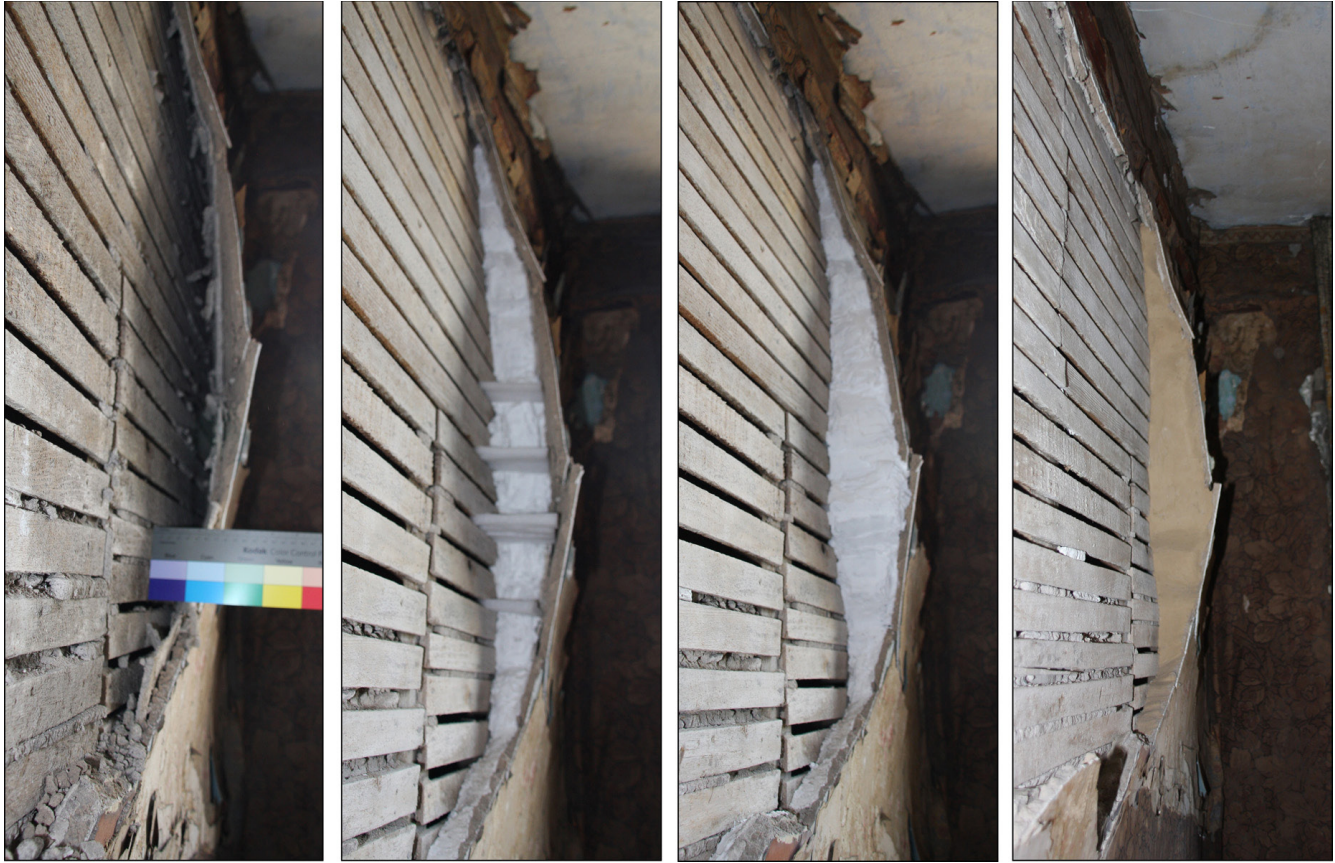
As the loss of the substrate, either paint or plaster, has an effect on the paper finishes, these elements have also had to be addressed. In several apartments, multiple layers of wallpaper have been applied directly over oil-based finishes which themselves have been painted over water-soluble distemper paints. High humidity and water infiltration had caused the distemper paints to fail. As the loss of paint leads to additional loss of paper, stabilizing the paint had to be part of the wallpaper stabilization.

Fig. 7. Stabilization of the plaster substrate to prevent additional wallpaper loss.

Flaking paint was stabilized using a 10% solution of Aquazol 200 in water applied with a natural bristle brush. Working in small sections, three applications of the Aquazol 200 solution were applied and then using a sheet of silicone paper against the surface of the paint, slight pressure was applied to the area. Larger paint chips that were completely loose from the plaster but which remained in place were re-adhered with an application of Jade R adhesive to the back of the sample and reset using tweezers. Once a smooth, stable

surface was achieved, the wallpaper was re-secured to the substrate using pins and Jade R adhesive where applicable.

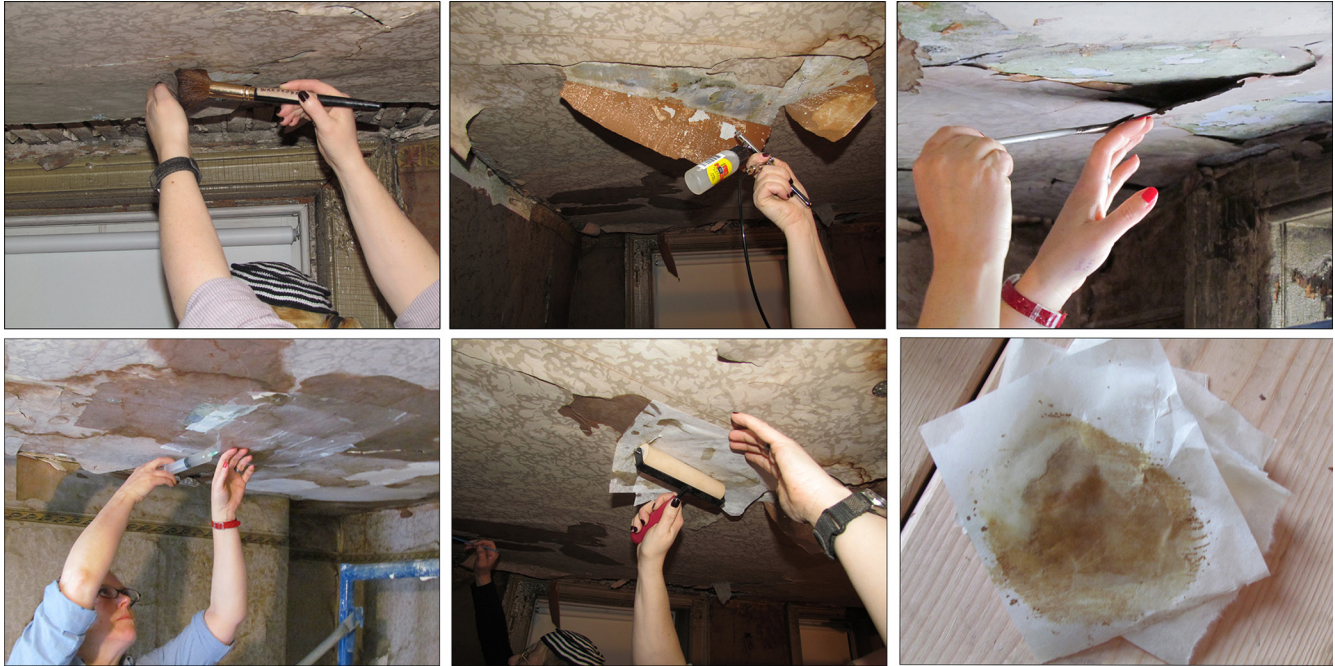
Fig. 8. Process of wallpaper stabilization using Tri-funori includes cleaning, consolidating, re-adhering, saturating, flattening, and cleaning.

not leaving tidemarks on paper as it dries, unacceptable staining occurred in areas where the funori was applied on the Kraft wallpaper. In an effort to determine if the paper was being over-saturated by the application methods, testing was performed applying the funori with an air sprayer. The spray application method also discolored the paper and reduced the sheen of the silver-colored printing ink on the paper. In an effort to determine if it was the conservation treatment, or the material being conserved that was causing the staining, the funori/sturgeon glue mixture was tested on an old newspaper dating to 1935. The funori left no tide marks or staining on the newspaper, indicating there was some element either in the historic wallpaper, glue, or printing ink which was reacting negatively with the funori.

Prior to conserving the wallpaper, the backs of all of the detached papers were cleaned using a soft natural bristle brush. Three coats of funori were then spray-applied to the exposed distemper paints on the plaster. Over time these water soluble paints had become powdery and friable.

After the distemper paints had been consolidated, pieces of hanging paper were re-attached. Using natural bristle brushes, the funori/sturgeon glue mixture was applied to the exposed plaster and the back of the wallpaper which was then gently pushed back flat against the plaster. If the papers were extremely brittle, the surface was gently misted to soften it enough so that it would not break when returned to its original position. A second coat of the funori mixture was applied to the face of the wallpaper over a small square of Japanese tissue paper. For larger sections of detached wallpaper, an additional application of the mixture was injected behind the wallpaper to saturate it. Once the entire piece of failed wallpaper was re-adhered to the substrate, a wallpaper seam roller was rolled across the surface to remove any air pockets or creases. After the wallpaper was secured, the tissue was removed, taking care not to disrupt the bond between the wallpaper and substrate.

A side benefit of the re-adhesion process was that the funori and tissue application also cleaned the wallpapers, many of which were heavily stained from water damage (fig. 8).

Brittle, curled edges of the wallpaper which could not be flattened were consolidated and strengthened using an airbrush application of the funori/sturgeon glue mixture. Some detached pieces were left in the hanging position with a strip of Japanese tissue secured to the back with the funori/sturgeon glue mixture to provide additional support. This retained the “ruined” look of the wallpaper by leaving strips hanging from the ceiling or puckered from the wall.
