The Restoration of a 34 cm Terrestrial Globe by Blaau

Michael Højlund Rasmussen
paperconservator

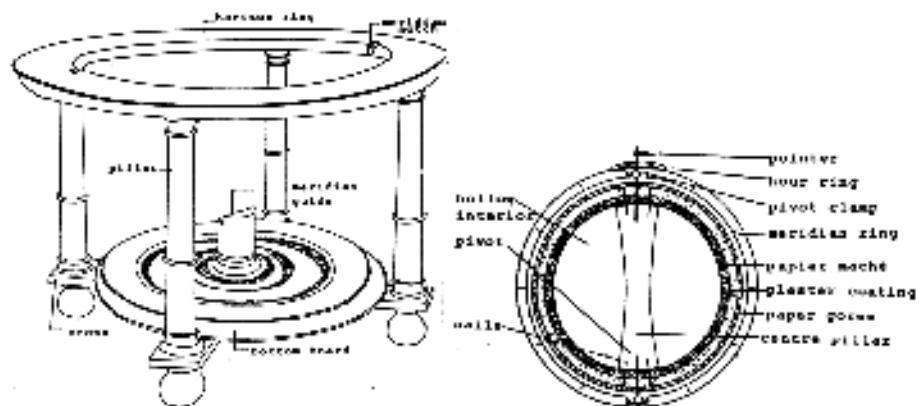
Fig.3 The parts of the stand Fig.4 The construction of a globe

and the meridianring would rotate within the stand. Usually an bearing with a little pointer was present on top of the meridianring. (see Figs.3,4).

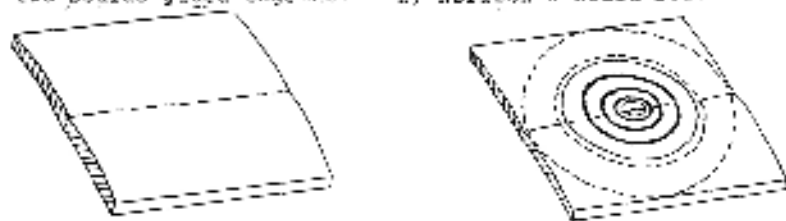
Fig.5 The construction of the bottom board

Moreover, it was evident that the bottom-board was cut out of the same board of wood as the horizonring. By comparing the patterns of the engrained wood of the horizonring and the bottom board they proved similar - and so did the shrinkage. Hence the working procedure has been as follows. (see fig. 5).

Two boards of oak approx. 2 cm of thickness were glued together forming a square board. This was placed in a lathe and turned circular. The decorative grooves of the bottom board were carried out after which the ring was parted from the board using a parting tool. Four holes were drilled in the ring to receive the top-pins of the pillars. As the horizonring shrank the pins stuck up above the paper-surface and were visible. This is often seen on dutch-type stands.

a) two boards glued together b) horizon & board before turning

The restoration of the stand was perhaps the most exciting part of the enterprise. As mentioned above the horizon-paper and the horizonring did not fit very well together as the wooden ring had shrunk. In order to save the badly deteriorated paper from being completely disintegrated by tannic acid it was decided to try to peel off the horizon-paper. Another advantage gained by this procedure was the opportunity to restore the wooden ring as well as the paper to its original size. Being aware that such a treatment perhaps was a very hazardous solution to the shrinkage-problem every precaution was taken not to damage the paper. First the paper was cleaned in exactly the same way as the globe. Here it was clearer that the paper had been waxpolished, so again several organic solvents were tested but without any satisfactory results. After having cleaned as much as possible with the methylcellulose/water swabs the paper was ready to be taken off. The horizon-paper was pasted down in 4 pieces the joints following 4 scratches on the wooden ring. The paper was covered with lense-tissue and a thick solution of methylcellulose was pasted through it in order to safeguard the fragile paper on the ring and to retain the moisture to the paper. After this steam was applied by use of a hand steam-cleaner (Rowenta DA-55) and the paper was removed using tweezers and a scalpel. The lense-tissue was a great help during this process; fragments were kept together and it served as a transport. After the removal of the four horizonpapers they were gently washed in hot water and deacidified from the back with a 0,2 % solution of CaOH. In order to remove the protective lense-tissue from the surface the papers were lined on the back with a very thin kozo paper and wheat starch paste. Furthermore, the papers were lined with a rather thick kozo paper which had previously been treated with a 0,2 % solution of CaOH - this should serve as a buffer when pasted onto the oak-ring. Before pasting on the paper the ring was restored to its original size by inserting two pieces of oak-wood in the broken joints. By gently stretching the paper it was made fit the enlarged horizonring.
