# Illuminating Art Using a Daylight System at the Broad Contemporary Art Museum

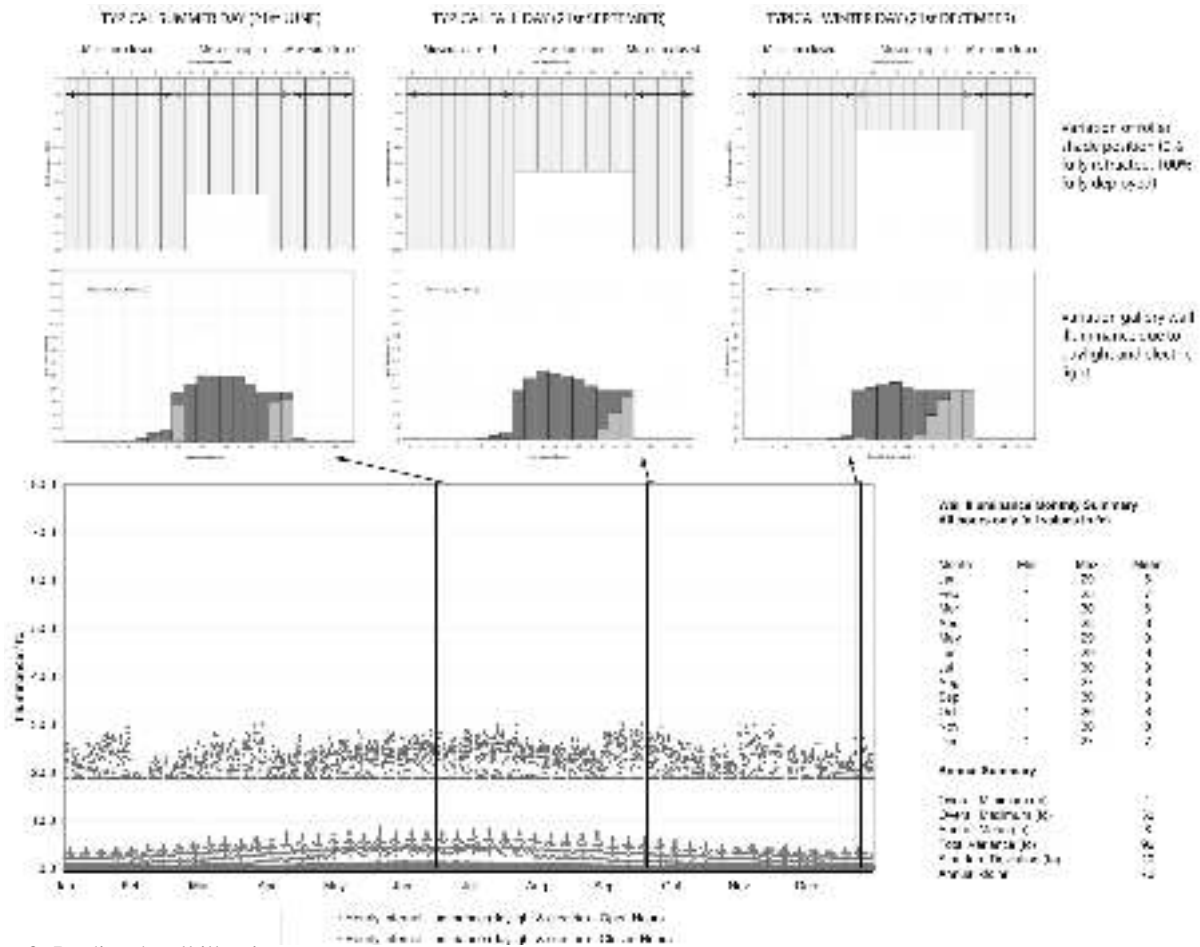
Figure 3 Predicted wall illuminance

The following series of diagrams illustrate the variation in wall illuminance at six feet above floor level due to natural and electric lighting within the third floor galleries predicted by the daylight and sun factor analysis incorporating the operational parameters discussed above (Figure 3). These diagrams illustrate how maximum natural light levels within the galleries can be controlled by partially deploying the roller shades. Predicted illuminance readings are illustrated for a typical summer, fall, and winter day.

When compared with predicted values illustrated in Figure 3, it is readily apparent that the measured wall illuminance was not always greater than or equal to 19fc as predicted for daylight linking for all museum open hours. The contribution to the gallery light levels provided by the gallery track lighting and the daylight linking system proved difficult to assess.

In general, the system failed to maintain the minimum 19 fc of illumination in the galleries (as defined in the program) during the fall and winter months when the natural light levels fell below 19 fc in the late afternoons and evening hours. This is probably a reflection of the number of gallery lights installed in the gallery which was not sufficient to generate the required wall illumination.
